Accurate Building Consultants, LLC  
4531 Athens Boonesboro Rd.  
Lexington, KY 40509

123 Anywhere Lane  
Lexington, Kentucky 40515

**General Information**

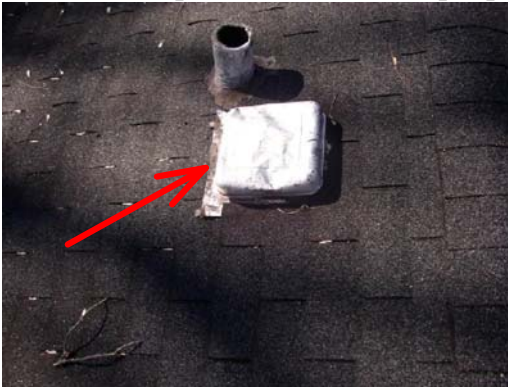
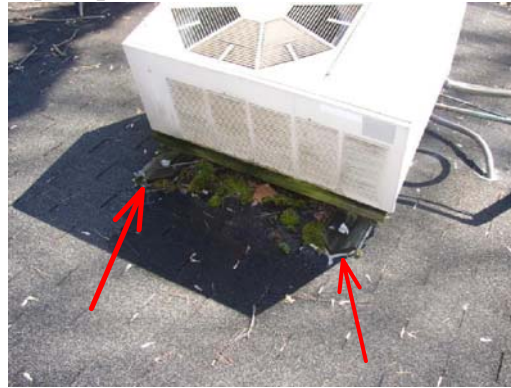
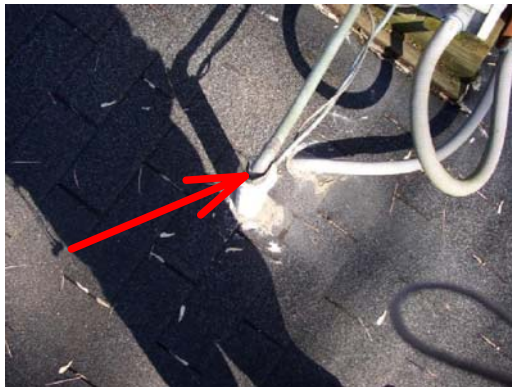
| 3. Defective | <b>Material:</b> Asphalt shingle The roof has 2 layers of roofing. It is showing environmental staining and show signs of cupping and cracking and is near the end of its service life. We recommend budgeting for a roof replacement by a qualified roofing contractor as soon as possible. |

- 6. Defective      **Flashing:** Galvanized    The flashing on several of the roof vents has raised away from the roof surface. There are also exposed nails and deteriorated roof caulking. The caulking around the plumbing vents also shows signs of deterioration. The caulking around the air conditioning support timbers is deteriorated. The caulk is deteriorated where the air conditioner refrigerant lines penetrate the roof through the PVC conduit. We recommend that a qualified roofer properly repair each of these items.
- 7. Acceptable    **Plumbing Vents:** Galvanized
- 8. Acceptable    **Electrical Mast:** Mast at roof level
- 9. Acceptable    **Gutters:** Aluminum    The front left gutter is pulling down away from the fascia board.
- 10. Acceptable   **Downspouts:** Aluminum

3. **Main Roof Surface Material:** Asphalt shingle The roof has 2 layers of roofing. It is showing environmental staining and show signs of cupping and cracking and is near the end of its service life. We recommend budgeting for a roof replacement by a qualified roofing contractor as soon as possible.
4. **Flashing:** Galvanized The flashing on several of the roof vents has raised away from the roof surface. There are also exposed nails and deteriorated roof caulking. The caulking around the plumbing vents also shows signs of deterioration. The caulking around the air conditioning support timbers is deteriorated. The caulk is deteriorated where the air conditioner refrigerant lines penetrate the roof through the PVC conduit. We recommend that a qualified roofer properly repair each of these items.

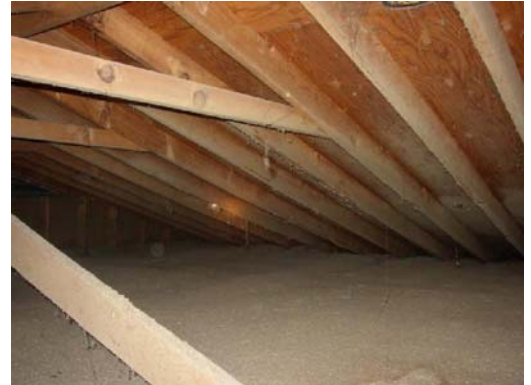
- 3. Defective       **Roof Framing:** 2x6 Rafter     A visual observation of the left rear roof system indicates sagging rafters and roof sheathing.     The 2x6 rafters on the left rear of the house do not have knee walls over load bearing walls for proper support.     We recommend that a qualified contractor evaluate the roof system and recommend repairs.

11. **Main Attic Unable to Inspect:** 40% The second step from the bottom of the attic access stairs is missing which causes an unsafe climbing condition. We recommend this be properly repaired.
12. **Main Attic Roof Framing:** 2x6 Rafter A visual observation of the left rear roof system indicates sagging rafters and roof sheathing. The 2x6 rafters on the left rear of the house do not have knee walls over load bearing walls for proper support. We recommend that a qualified contractor evaluate the roof system and recommend repairs.
